The Grove

(formerly Loretto Rest)

Inventory of Surviving Historic Fabric

VILLAGE OF COLD SPRING, NEW YORK
The Grove Inventory of Surviving Historic Fabric
(formerly Loretto Rest)

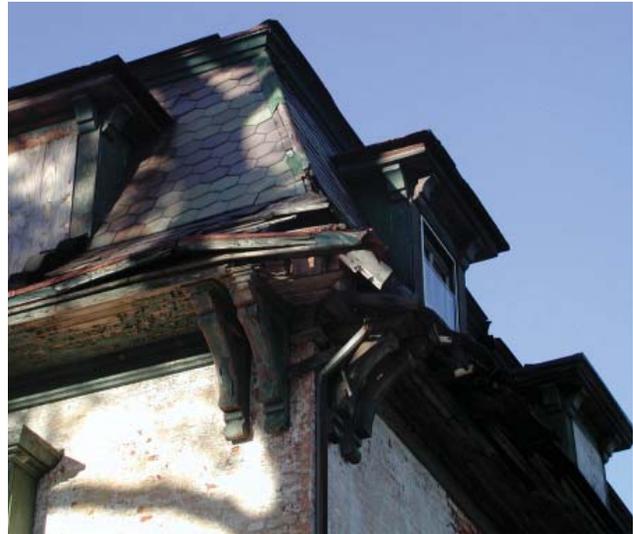
Damage to the cornice at the south west corner provides a window through which to see evidence of the original roof.

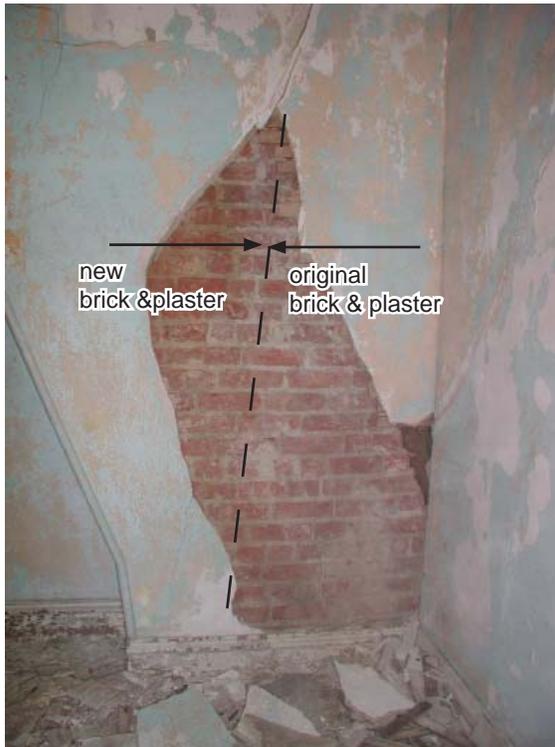
Photo 1 : A probe reveals different construction phases of third floor hallway walls.

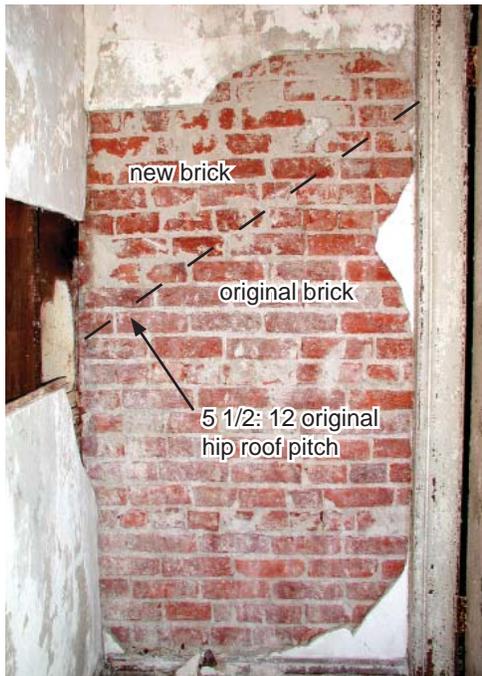
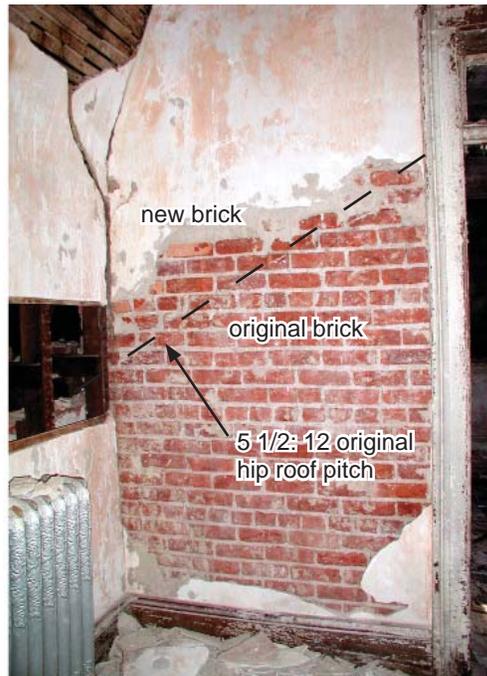
Photo 2a & 2b: Plaster ghost mark on two of the hallway walls.

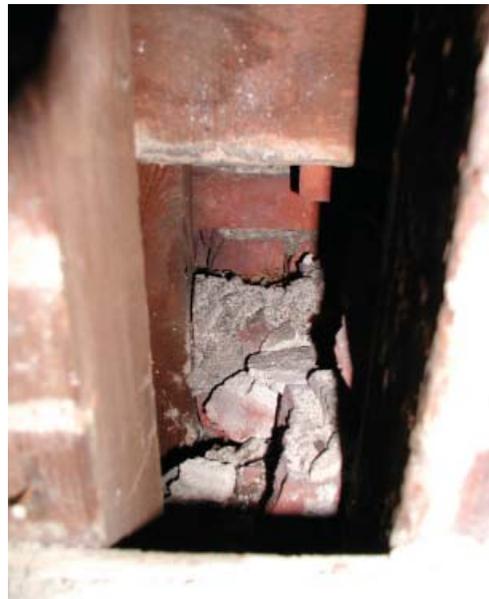
We also think that the slates would have been in great shape and would have been salvaged for re-installation on the Mansard. Conjecture - but it does make some sense - especially if Lente was responsible for the Mansard roof. Some of the letters talk about financial constraints; it may have been that he needed to be economical on the Mansard roof project. The existing rafters (a much steeper roof) are 2x6 at 24" on center (Photo 4). These rafters sit in the original notches; they look silly sitting in such a wide notch. This tells us that the top plate was not changed when the Mansard was built. Cuts in the top plate for the dormer windows (and ragged cuts they are) also tells us that the top plate is original (Photo 5).

Photo 5: Cuts in the top plate for the dormer windows.

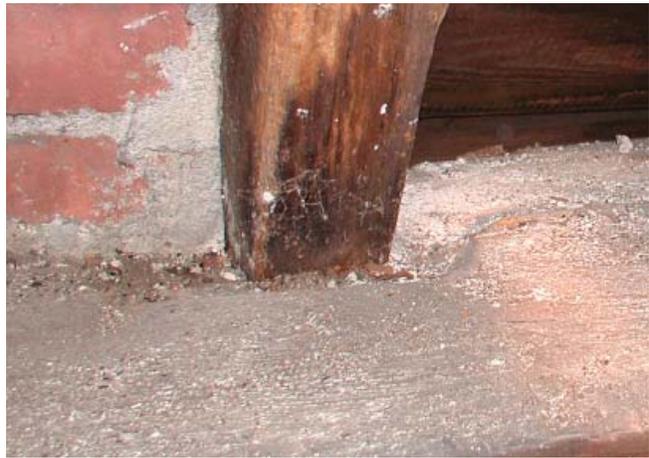
Our engineer, Joe Tortorella, from Robert Silman Associates, confirmed that the original 3x6 would have just worked for the original wood roof specs. He also confirmed that a heavier rafter would have been required for roof slates. Evidence (notches in the existing top plate to receive the original rafters) tells us that the rafters were 4" to 4 1/2" wide at 24" on center (Photo 6).

Photo 6 : Notches in the existing top plate to receive the original rafters.

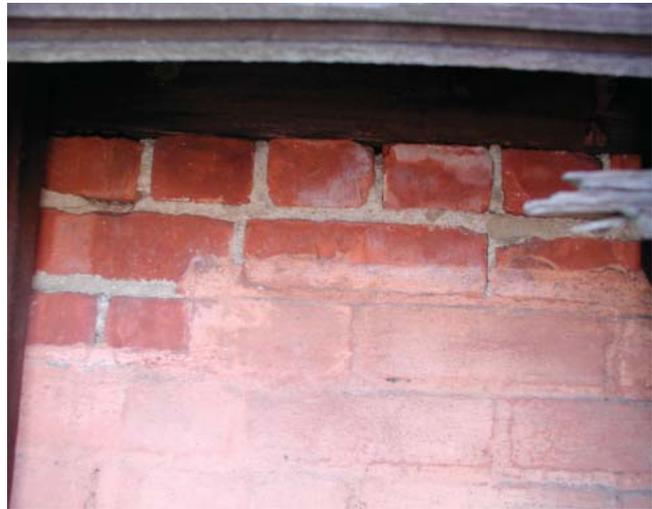
We also know that the perimeter brick walls were not extended when the Mansard roof was put on. The original flat bracket ghost marks exist from the hip roof era (Photo 7).

Photo 7: The original flat bracket ghost marks.

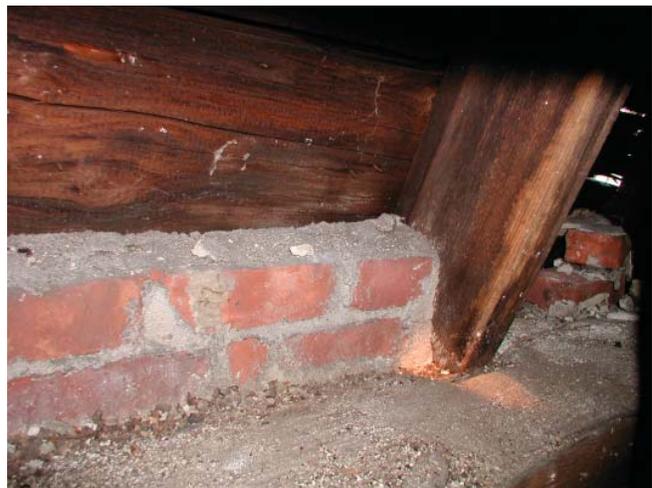
There is no change in coursing, bond pattern, or mortar type for the some 26" of brick wall above that. Brick was used to close in the voids between rafters. The brick "closers" were mortared to the top of the wood plate - something that would not have been done originally (Photo 8).

Photo 8: Brick "closers" were mortared to the top of the wood plate.

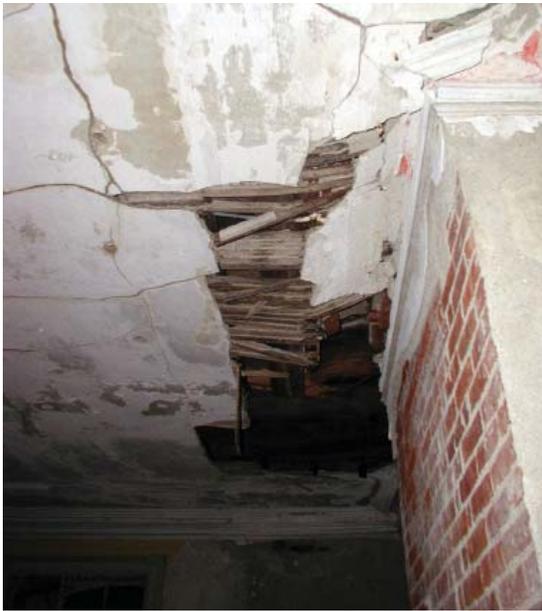
The ceiling above the chimney breast has suffered extensive water damage.

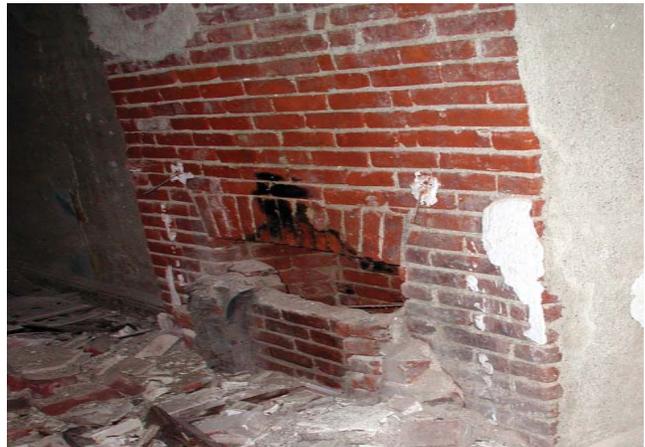
A pair of heavy wire ties on the chimney breast indicate a marble (or other stone) mantelpiece was installed here. Pieces of marble were found in the debris pile on the floor. All of these pieces should be salvaged and reassembled to determine the appearance of the mantelpiece. Part of a half-round, plaster-finished opening remains in front of the firebox.

Wire ties in the brick work indicate a marble or other stone mantel was installed in front of this chimney breast.

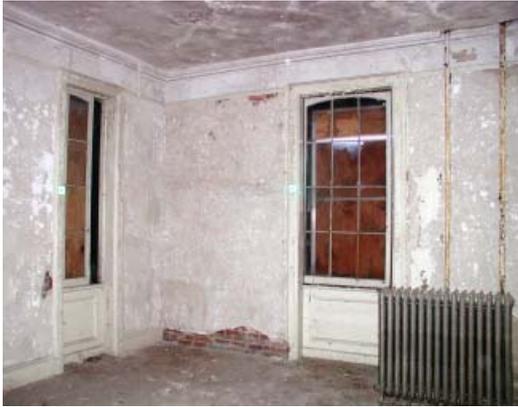
Room 103 has a plaster cornice and once had a ceiling medallion.

CEILING: The ceiling is plaster on lath and a plaster cornice runs the perimeter of the room. A ridge in the ceiling plaster suggests a medallion was installed at the center of the ceiling. Both the ceiling and cornice are extensively damaged. Sections of the cornice are missing at the chimney breast and where the radiator pipes continue through the ceiling to the second floor.

SALVAGE: Samples of the cornice should be salvaged for future replication. Pieces from two or three different ceiling medallions were found in the debris pile near the chimney breast; the rest of this debris should be sifted through for additional pieces. Paint samples should be taken from the ceiling field, each element of the cornice, and the salvaged pieces of the medallion(s).

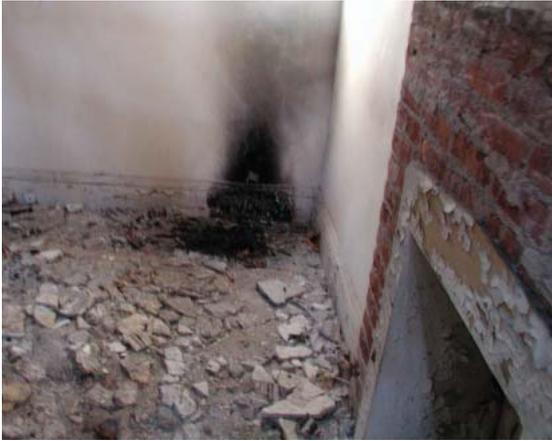
The bases board in room 106 has scorch marks.

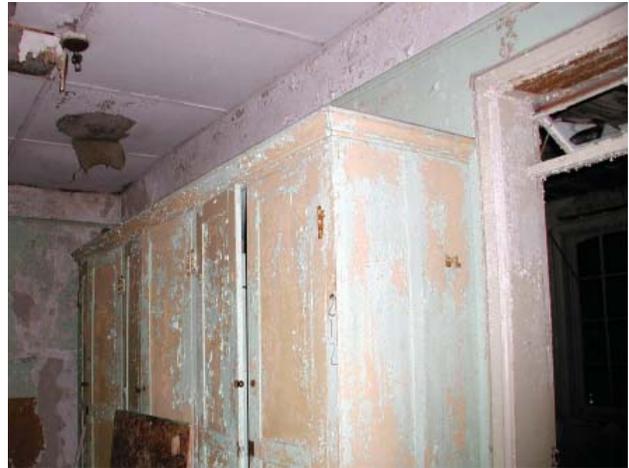
The closets on the north wall and the gypsum wallboard with wood grid ceiling are not original features.

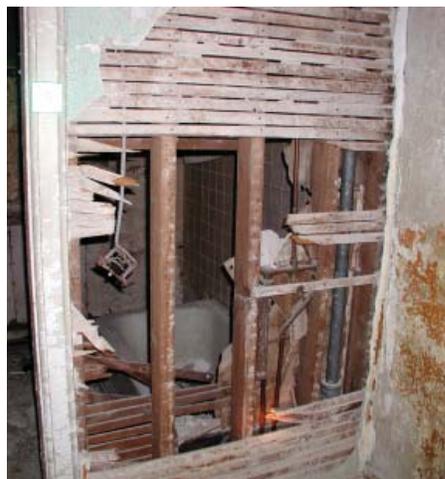
Damaged plaster on the east wall exposes original framing and sawn lath.

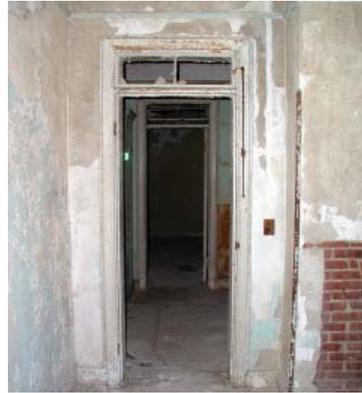
The door is missing from this opening.

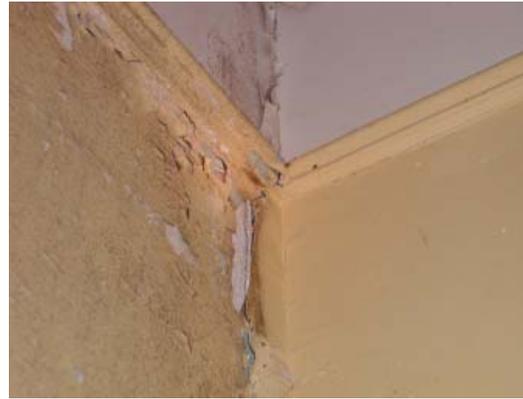
WALLS: All of the walls have a picture rail. The picture rail on the closet wall does not match the picture rail on the rest of the walls.

The two pieces of picture rail on the main wall (left), and on the closet wall (right) do not match.
